# Failure Analysis of Front Axle Wheel Studs in Small Commercial Vehicles

*Chassis Engineering - LCV PD, Ashok Leyland Technical Centre, Chennai.*

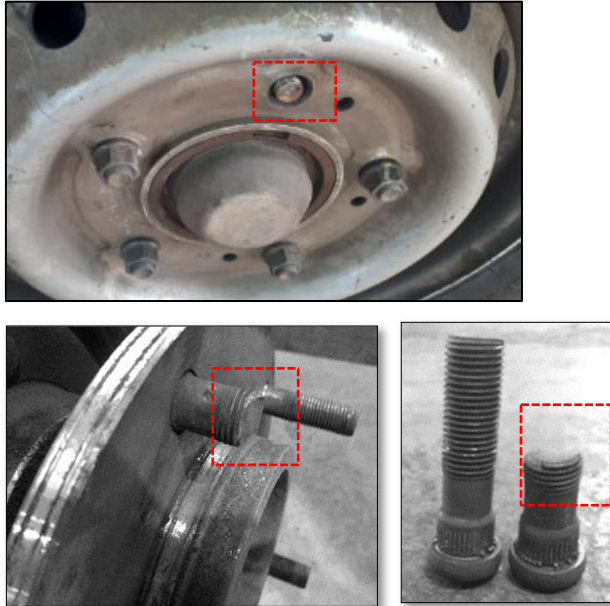
studs. Considerable number of the proto vehicles started exhibiting wheel stud failures only on the front RHS wheels (Right Hand Side of vehicle) after covering 70,000km in Highway as shown in Figure 1. Details of the failures are shown in Table.1

Fig. 1. Photographs of wheel stud failures.

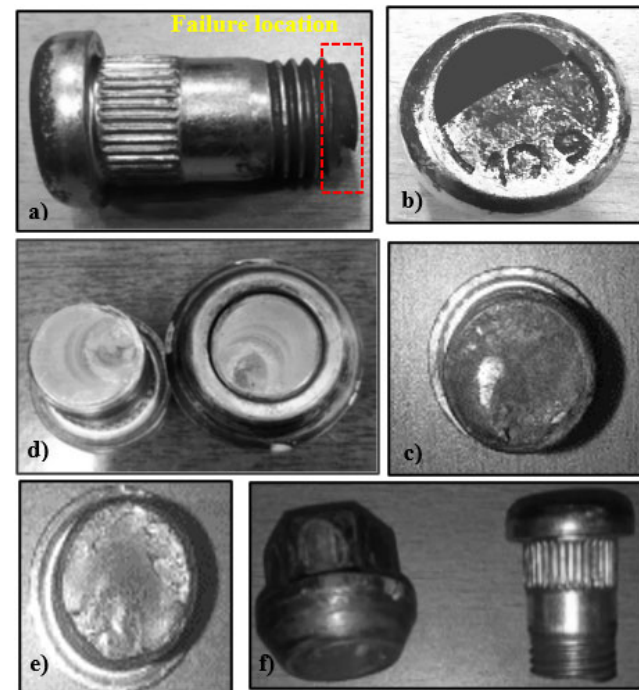
Figure. 2 (a) & (f) confirms that, the failure has happened between hub and wheel rim interface joints. Figure.2 (b) shows the grade identity of 10.9 on wheel stud which confirms to the specification. The failure mode is not obvious in Figure.2 (c) & (e). The section in Figure.2(d) reveals fatigue mode of failure.

Fig. 2. Visual Inspection of Failed Wheel Studs.

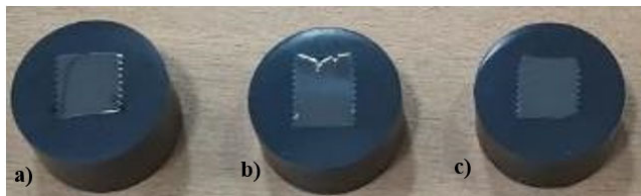
**Fig. 6.** Microstructure analysis – Cut Sections (a) Sample-1, (b) Sample-2, (c) Sample-3.

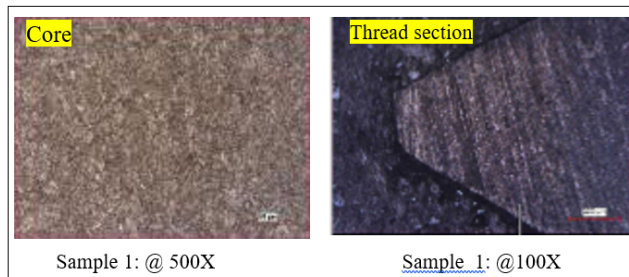
**Fig. 7.** Microstructure shows Tempered martensite in core & no decarb seen in thread.

No microstructure defects were found in both failed samples. Hydrogen embrittlement was not observed in all the stud samples. These test results conclude that failed stud samples are in agreement with the material specification and no abnormalities were observed.

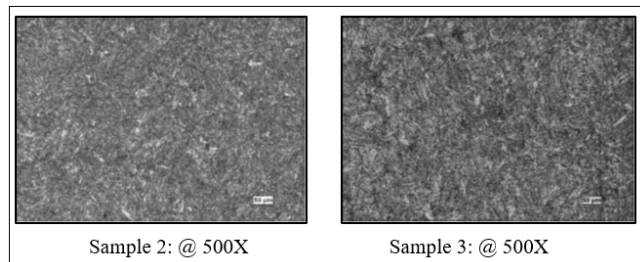
**Fig. 8.** Microstructure shows Tempered martensite together with bainite.

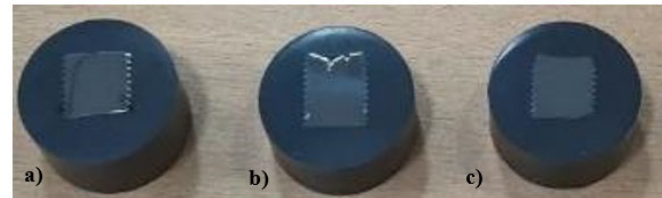
**Fig. 9.** Hardness Measurements - Test Specimen - Sections (a) Sample-1, (b) Sample-2, (c) Sample-3.

Multiple indentations were done at different positions at a distance of 2.5 times the indentation diameter from the test specimen edge to determine the variation in hardness from surface to the core. Core and surface hardness values were observed to be in the range from 33HRC to 37HRC which are in-line with the specification

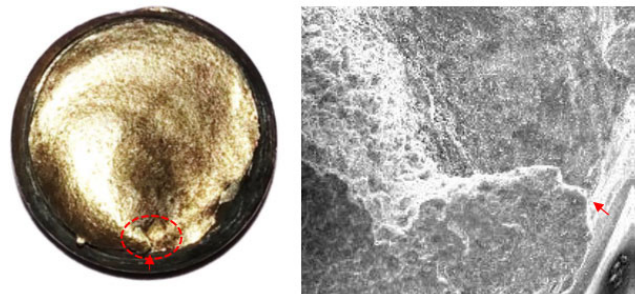
Fractographic analysis was carried out on three failed studs to identify the failure mode and sequence of failure. The analysis was done using Scanning Electron Microscope (SEM). Figure.10 depicts the images of areas pertaining to fracture surfaces of failed Stud sample-1. The most significant observation is that failure has initiated from thread root under torsional load. The SEM image reveals that, crack which had originated at the thread root had undergone propagation prior to final fracture. From Figure. 10, beach marks can be clearly seen indicating fatigue failure. Unsuitable wheel installation with deficient torquing practice have allowed for the possibility of very higher preloads on the studs leading to crack initiation at thread root. This crack could not have propagated under the influence of service loads. The slackening of the stud might have then set in allowing for unidirectional bending fatigue failure.

**Fig. 10.** Failed Stud Sample-1 & its fracture surface.

Metallurgical analysis of presented failed wheel studs reveals that all the wheel studs failed due to over tightening of wheel nuts causing too high pre-load to the wheel studs. The excessive tension in studs had resulted in yielding of the stud causing relaxation in tension. This pre-load relaxation in studs subjected them to cyclic loads during vehicle operation resulting in fatigue failure at the end. Since the design load calculations were intact, it was decided to go with a superior stud of same grade with improved fatigue properties which also should withstand the abusive torque tightening practices of the customers.

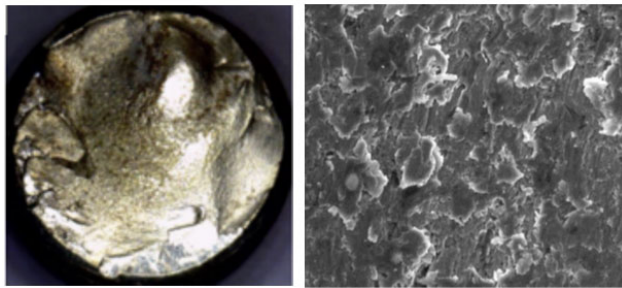
Figure 11. depicts failed stud sample-2 and fracture surface. It can be seen that mode of failure was unrecognizable by observing both failed sample and SEM

image. However this failure can be attributed to over-torquing of studs to some extent.

Fig. 11. Failed Stud Sample-2 & its fracture surface.

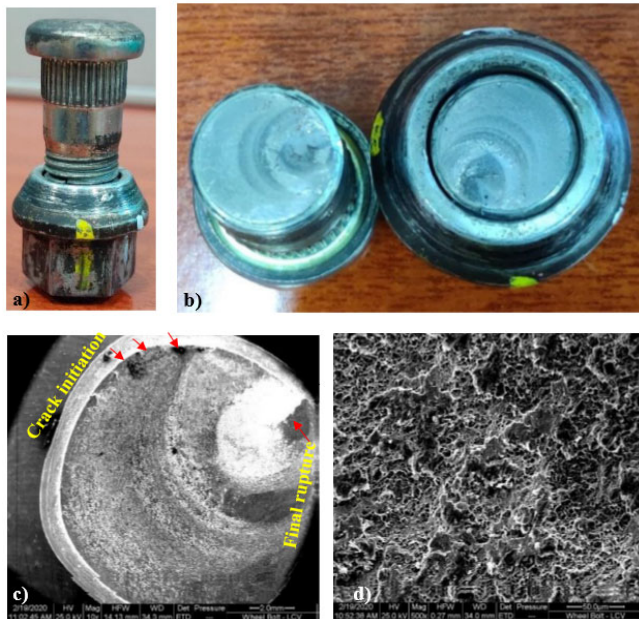
In Figure.12, failed stud sample-3 exhibits some significant results. Cracks are observed at the thread root of studs, with multiple initiation points. The adjacent SEM image corresponds to an area with the important presence of ductility fracture.

Fig.12. Failed Stud Sample-3 and its fracture surface & SEM image.

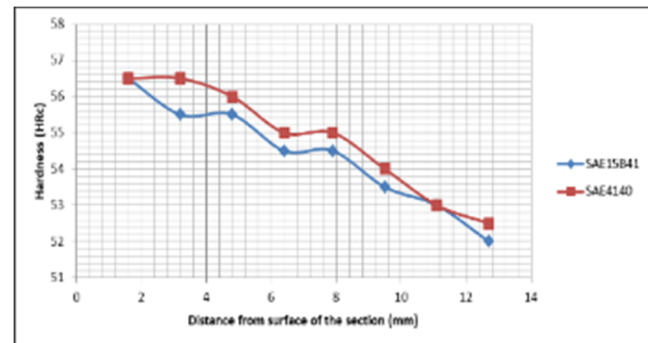
A comparison study on hardenability of materials SAE15B41 and SAE4140 was made and the results were plotted as shown in Figure 13. The graph clearly shows that SAE4140 has better hardenability compared to SAE15B41 owing to its additional composition of molybdenum and chromium. Bench level tests were conducted for abusive torquing conditions to corroborate the material analysis of SAE4140 wheel studs and are discussed further.

Fig. 13. Hardenability comparison of SAE4140 & SAE15B41.

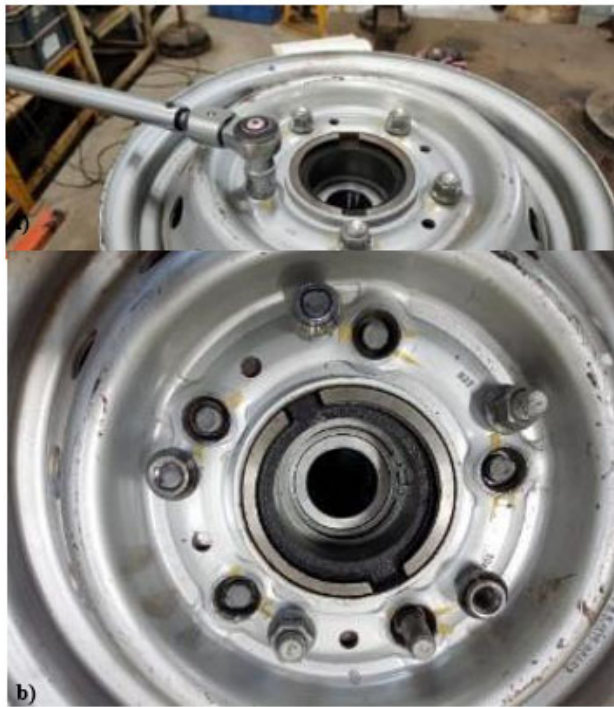
Among the five studs, four were torqued until failure and one was torqued till crack initiation by gradually increasing the torque as shown in Figure 14(b). Failed studs of material - SAE 15B41 is shown in Figure.15(a),(b) & (e).

**Fig. 14.** Bench Level Abusive Torqueing Test: (a) Fixture setup for torque test, (b) Bolts failed due to abusive torqueing.

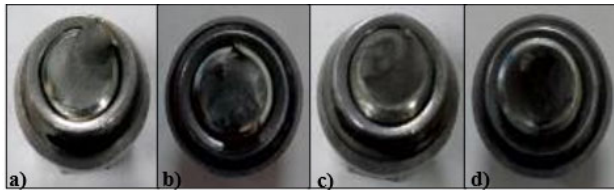
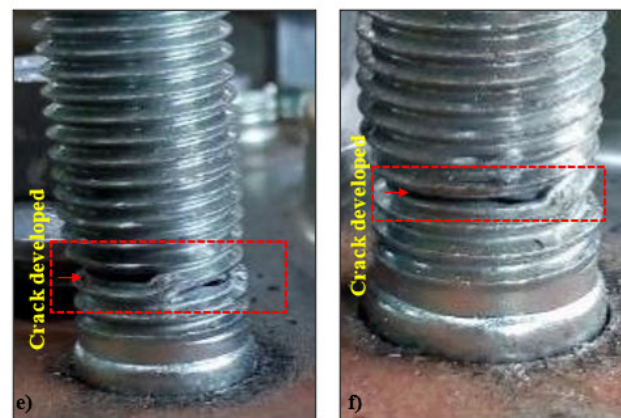
**Fig. 15.** Studs failed abusive torqueing test: (a),(b) & (e) – SAE 15B41; (c),(d) & (f) – SAE 4140.

The abusive torqueing test was repeated with the studs of proposed material-SAE4140 using the same setup as explained above. Failed studs of material - SAE4140 is shown in Figure.15(c),(d) & (f). By physical observation, it can be confirmed that, failure has originated from the thread root under torsional load.

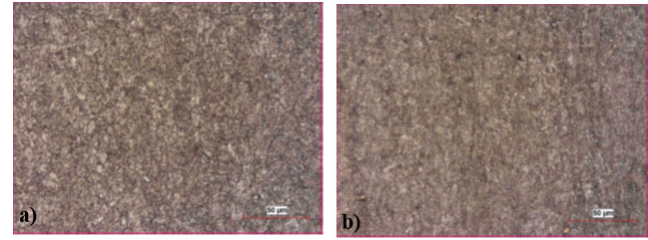
**Fig.16.** Microstructure analysis @500x: (a) – SAE 4140 showing tempered martensite, (b) – SAE 15B41 showing tempered martensite.

The samples failed by bench test were subjected to metallurgical and fractography analysis for study. By microstructural analysis, there were observed no abnormalities in terms of decarburization or internal oxidation in both SAE5B41 & SAE4140 bolts as shown in Figure.16. The surface and core microstructures were observed to be tempered martensite.

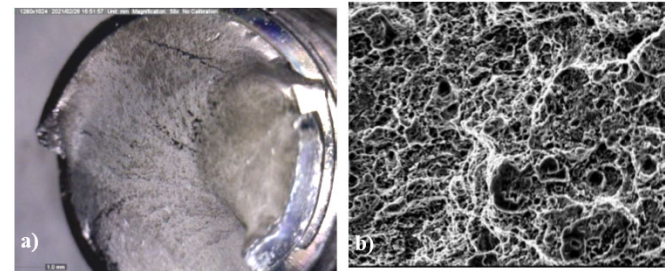
The fractography study which is shown in Figure.17&18 reveals that, failure had been initiated from the thread root and progressed towards the core section. The fracture surface reveals dimple mode failure, which indicates ductile failure by excess torsional load.

**Fig. 17.** Fractography analysis of SAE 4140 studs failed by bench level abusive torqueing test (a) - Dino image shows fracture surface at stud thread, (b) - SEM image @ 1000x magnification shows dimples indicating ductile mode of failure.

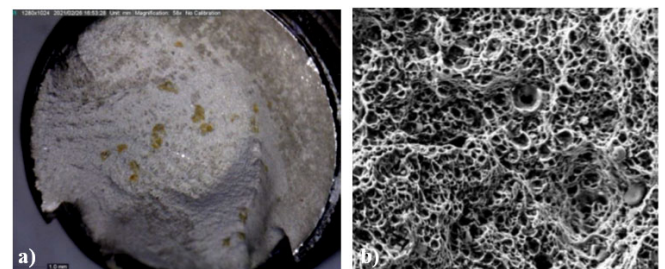
**Fig. 18.** Fractography analysis of SAE15B41 studs failed by bench level abusive torqueing test (a) - Dino image shows fracture surface at stud thread, (b) - SEM image @ 1000x magnification shows dimples indicating ductile mode of failure.

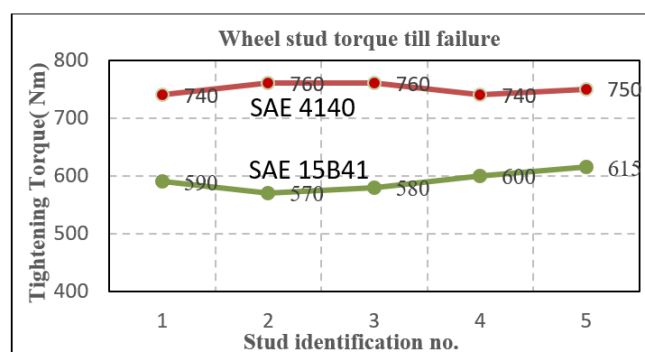
From abusive torqueing test, it is evident that, proposed SAE 4140 wheel stud is capable of withstanding higher abusive torque of 750Nm(avg.) than existing SAE15B41 wheel stud which was able to withstand only 591Nm(avg.). The comparison of abusive torque test results are shown in Figure. 19.

**Fig. 19.** Abusive torque test results comparison between SAE4140 & SAE15B1.
