Bilateral Facet Dislocations With and Without Head Impact Sustained by Restrained Occupants

ABSTRACT

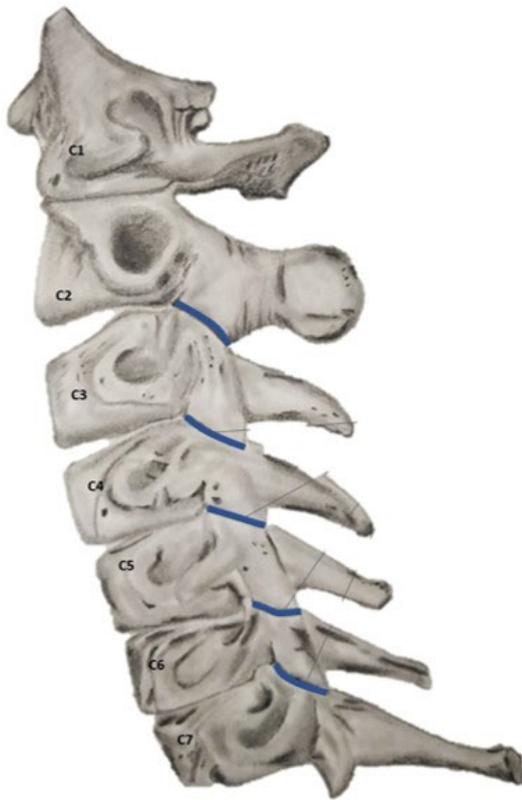
Fig. 1. Schematic of cervical spine from side showing facet joints and pillars.

The human cervical spine consists of seven vertebrae interconnected by articulating joints and tissues supporting the human head. Facet joints, also known as Zygapophysial joints, can be best visualized from the side laterally. The neural arch (dorsal part) of typical vertebrae supports seven processes: four articular processes, two transverse processes, and one spinous process. The superior and inferior articular process on each side forms an articular pillar. The articulating joints between these pillars are called facet joints. The articulating surfaces of these pillars are at an angle steeper in the upper region than in the lower region. Figure 1 shows the side view of the cervical spine highlighting the facets joints and pillars, forming articulating joints of the cervical spine.

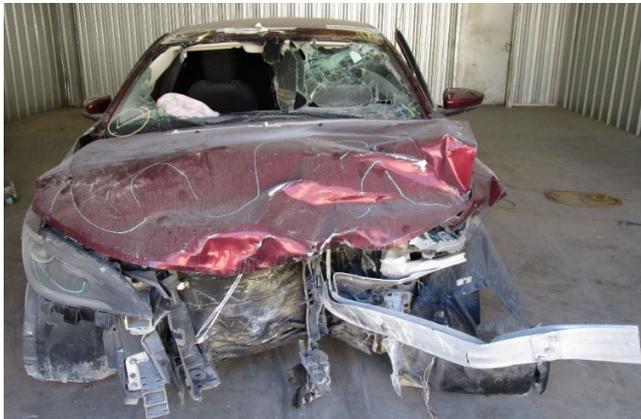
scale) of 13. Her physical assessment at the scene showed abrasion to both hips, abrasion, and avulsion to her left neck and chest area with no other visible injury. She complained about abdominal pain and complete numbness in all four extremities. The vehicle inspection showed that the vehicle's damage was limited to the frontal body, with almost no intrusion into the front occupant's survival space.

Figure 4 shows the damage pattern on the vehicle. The vehicle EDR data recorded 39.0 mph as longitudinal Delta-V in 100 ms and 6.2 mph for lateral Delta-V. All available frontal airbags for the driver and the front passenger also deployed along with the driver side curtain airbag and the driver seat-mounted thorax airbag.

Fig. 4. Exterior damage pattern on the vehicle.

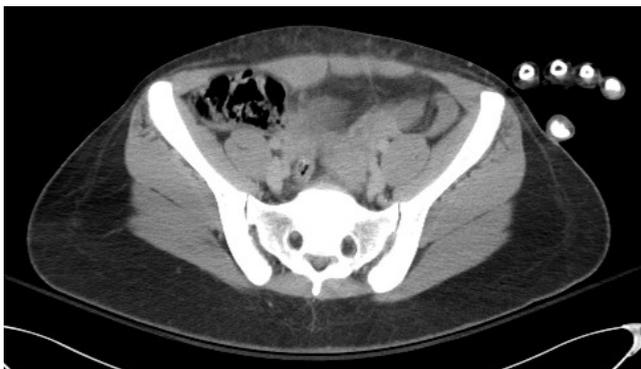
The inspection of left rear seatbelt webbing and the hardware showed load marks consistent with proper use of the seatbelt. Furthermore, the fat stranding analysis using CT (Computed tomography) imaging scans of pelvis and abdomen indicates proper placement of the lap belt before the crash.

Fig. 5. Fat stranding as visible on the CT abdomen at A.S.I.S level.

Occupant submarining on the seat causes the seatbelt migrations from the stronger skeletal sites to the undesirable sites such as the abdomen and the neck [14,15,16,17]. Hence, to eliminate the BFD injury risk due to the belt fulcrum formation in a frontal crash, it is reasonable to implement a restraint design that prevents occupant submarining.

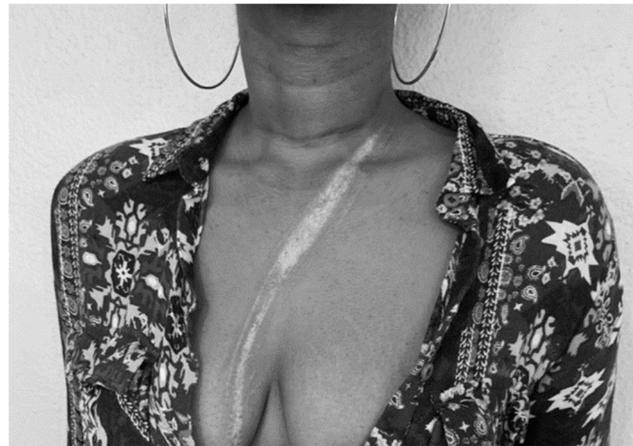
Figure 5 shows the fat stranding at the ASIS (anterior superior iliac spine) due to lap belt loading during the subject frontal crash. Figure 6 shows the shoulder belt loading marks on the body near the base of the neck on the left. Figure 7 shows the C5-C6 dislocation pattern that involves bilateral facet dislocation with the widening of posterior disc space and interspinous space with disruption of the disc. The imaging studies also revealed cerebrovascular injury at the dislocation level.

Fig. 6. Shoulder belt injury marks.

In the frontal crash scenario, the shoulder belt migration near the base of the neck and acting as a fulcrum imposes constraints and kinematics capable of producing BFD and cord injury, and hence, it must be a vital restraint design performance criteria.

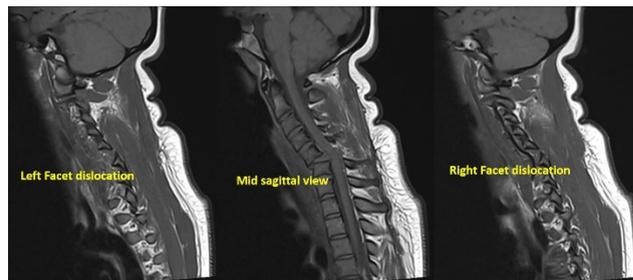
Fig. 7. C5-C6 level dislocation with ligamentous injury occurred in the frontal crash.

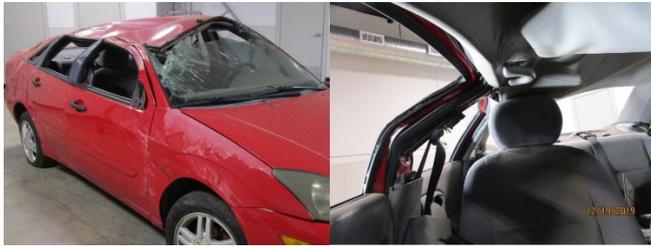
Figure 8 shows the roof crush profile of the vehicle from outside and inside. Figure 9 shows the hair deposit on the roof substrate, as observed during the vehicle inspection. Figure 10 shows the local roof deformation pattern from inside above the occupant's head.

Fig. 8. Vehicle roof crush profile.

Similarly, in the rollover crash scenario, the roof high rate intrusion and the roof's capability to impose head rotational constraint must be eliminated to design out the hazard of severe neck BFD injury. The alternative designs that prevent submarining or roof designs maintaining structural integrity are not the focus of this paper. However, the study focuses on the conditions required to produce BFD in frontal and rollover crashes, which have been discussed using real-world examples.

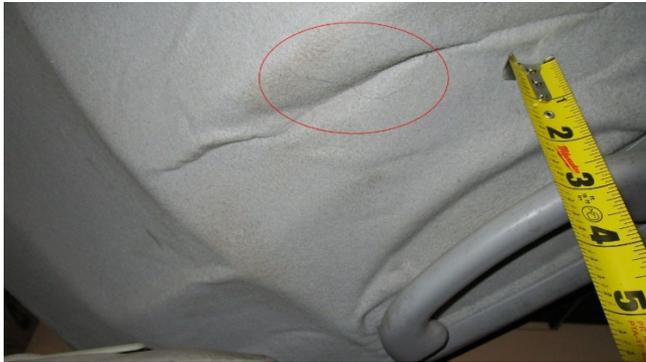
Fig. 9. Hair deposit on the interior roof substrate above occupant's head.

regarding the neck injury sustained in the rollover case study. The concomitant scalp hematoma and the hair deposit found on the headliner substrate confirm the roof's role in producing the BFD in a rollover crash.

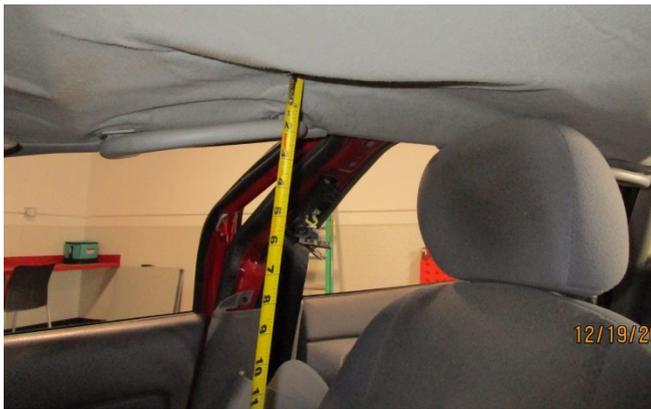
Fig. 10. Roof deformation pattern above the occupant's head.

Furthermore, the vehicle roof's failure pattern shows the pocketing effects in the headliner substrate, confirming head rotational constraint produced by the roof. The roof intrusion caused a traumatic head impact

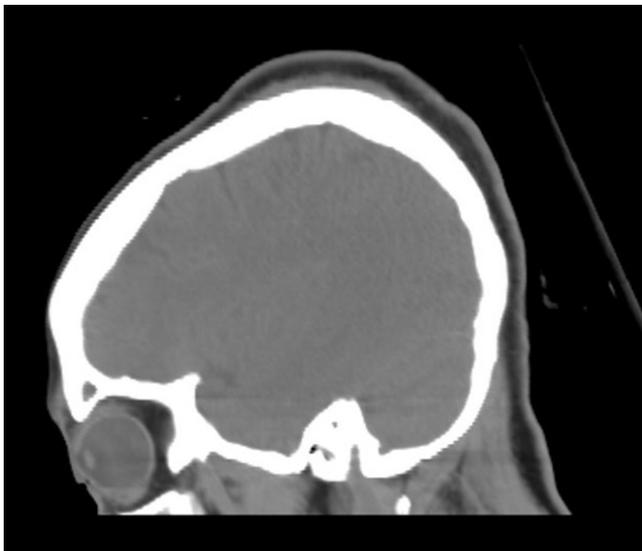
She was unable to move or feel anything below her upper chest at the scene. She also sustained an acute bilateral traumatic cerebrovascular injury at the dislocation level. The imaging studies also showed the scalp head injury with no underlying skull fracture.

The belt inspection shows consistent load marks on the webbing and the hardware confirming the proper use of the seatbelt. Figure 11 shows the head scan that shows the location of scalp hematoma on her head.

Fig. 11. Location of subcutaneous hematoma over the head.
